# Ashfield Conservation Area Character Statement

## 1.0 General Description

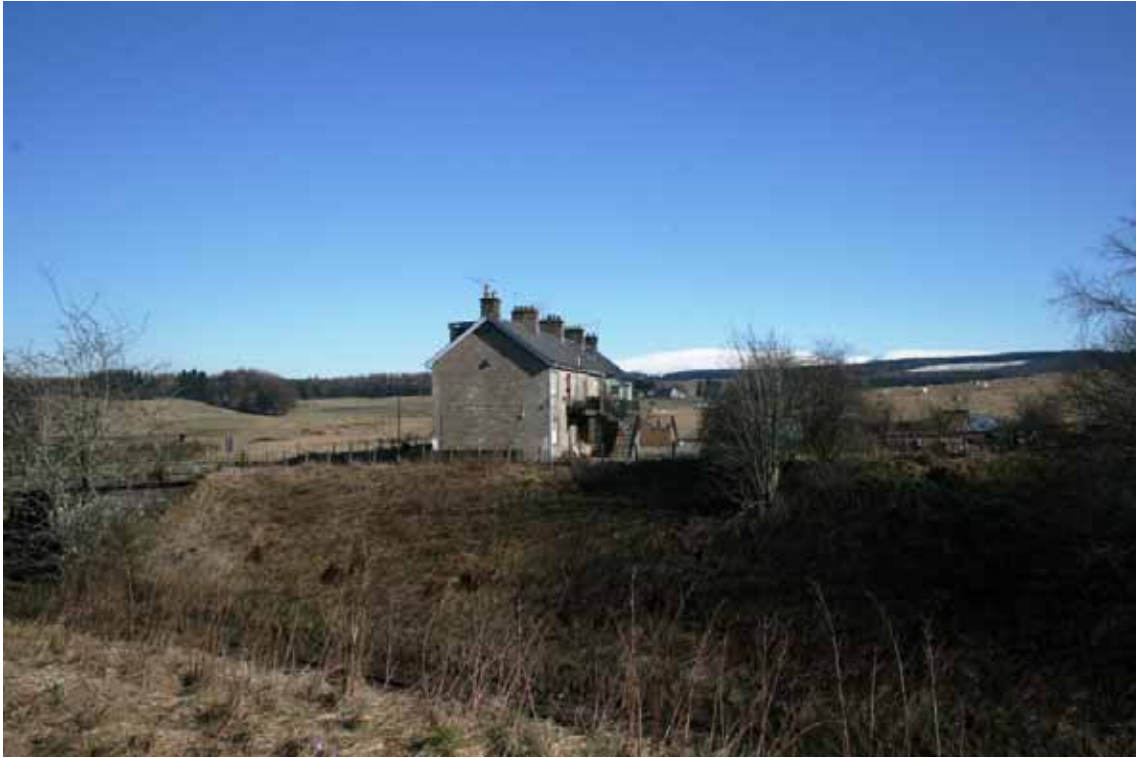
Fig 1: the singular road approach to the village passes The Clachan, the only building constructed in the east side of the railway line. The village is set amongst flat agricultural land with low hills in the distance.

**Ashfield Conservation Area** (Map 1 & 2) consists of the entire village including the former mill complex and planned model housing, the railway bridges and the Clachan. The singular approach road passes the Clachan, a row of 2-storey flatted cottages, before crossing the railway line into the village proper (fig 1).

<b>CONSERVATION AREA CONTEXT</b>	
Setting	A riverside location on an isolated loop of the Allan Water forming a distinctive triangular plot enclosed by the railway cutting to south-east.
Approach	By road through surrounding flat agricultural farm land and across railway bridge (fig 1). By foot along the river and across railway bridge; important approach by foot across field from A9 junction.
Topography	Largely flat site sloping towards the riverside to the west; as such properties on Allan View are reduced in scale (fig 4).
Views	Distant views to east of the Ochils; distant views north of Comrie moor uplands and Slymaback. In the village, views through into The Square.
Landmarks	The Square (fig 2).
Activity	Limited commercial activity at the mill complex.
<b>BUILDINGS AND TOWNSCAPE</b>	
Key Listed Buildings, Scheduled Monuments	No listed buildings or Scheduled Monuments.
Key Unlisted Buildings of Townscape Value	The Square, particularly single storey cottages and outbuildings (figs 2-6). The former mill; The Steading (fig 7); Ash Cottage; The Water Tower.

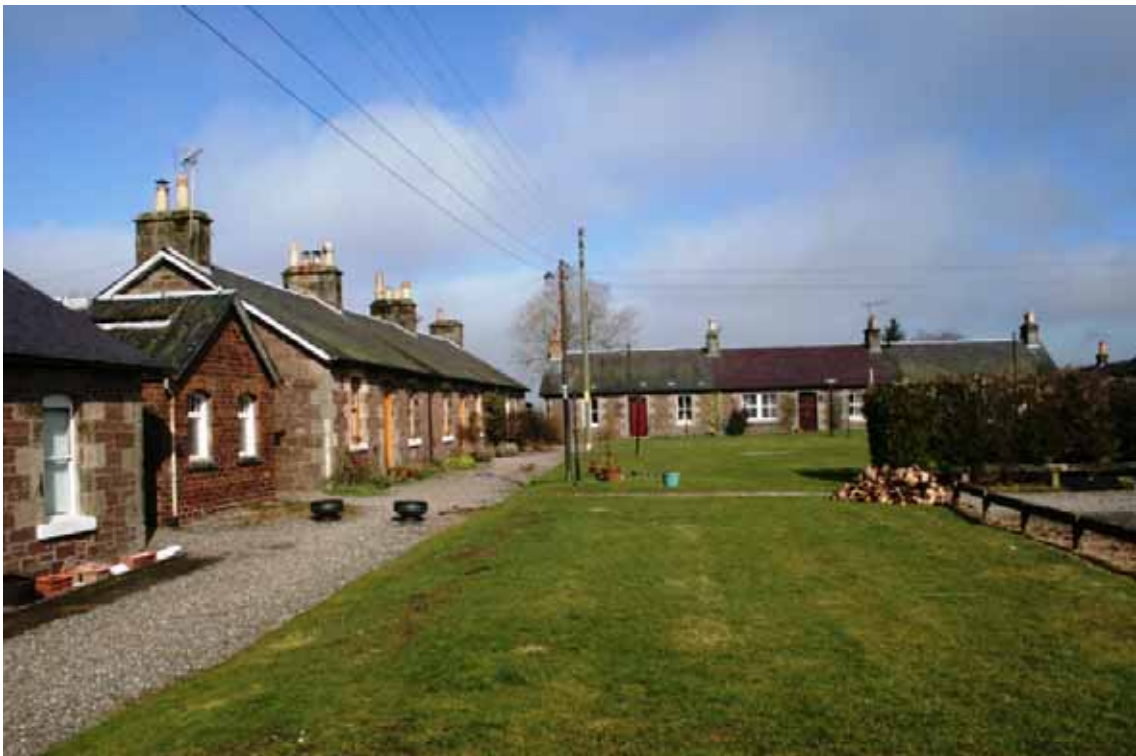
Fig 2: view looking north-east across The Square. The single storey cottages in groups of three 3-bay houses form a U plan around a communal drying green. Note the small brick building on the right, one of several former wash houses, privies and coal sheds which remain an integral part of the planned village.

The Square is the most formally planned part of the village, with workers' housing set out in short terraced blocks around a long rectangular green (Map 4). The existing north-east section of The Square comprises three sides of 3-in-a row, single storey 3-bay houses which form a strong U-plan group addressing a communal drying green (fig 2). These cottages are little altered and form a very coherent group. The south-west section of The Square is less defined, enclosed on only two sides by the single storey cottages on the north-west and a symmetrical 2-storey row on the south-west (fig 3). The remainder of the south-east section has been demolished (section 2.0; Map 2) and is now open with private gardens and car parking. A number of small brick buildings (former wash houses, privies and coal sheds) are located between the cottages and add character to the setting (figs 2 & 6).

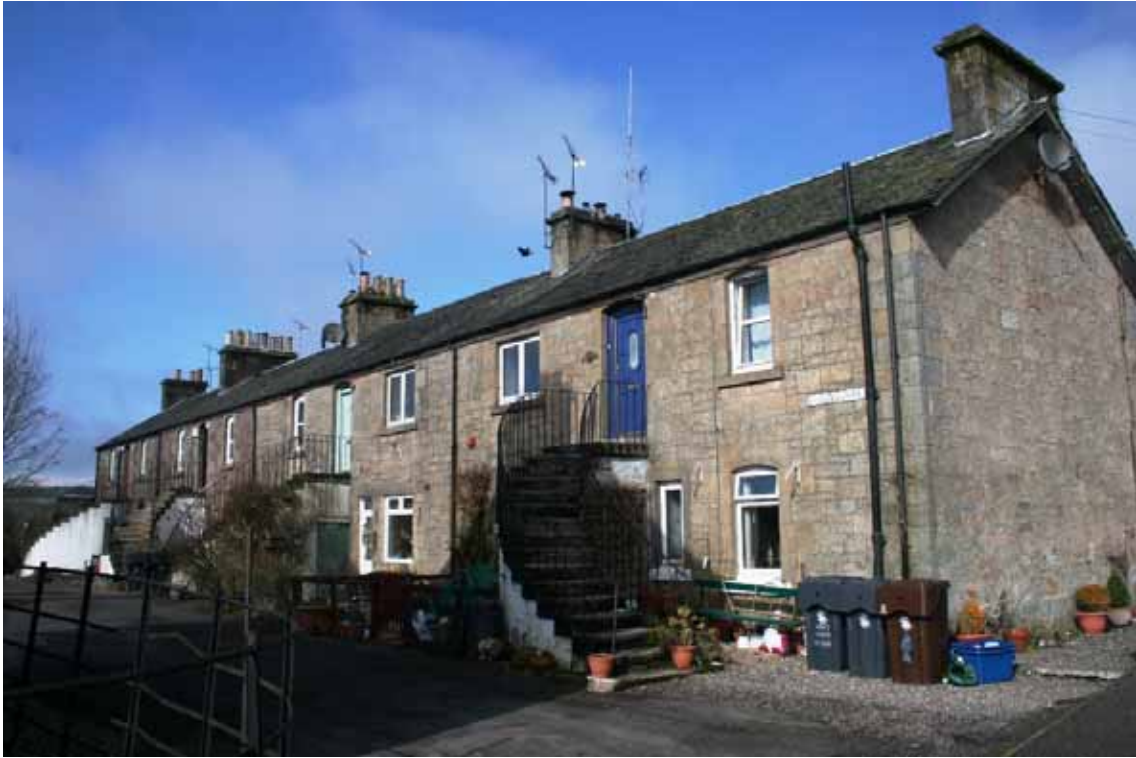
Fig 3: the 'rear' façade of the south-west range of The Square. Properties were designed as flatted houses with attractive curved entrance stairs contrasting with the otherwise regular form of the buildings. Note there has been considerable detrimental change to this block, including inappropriate replacement window types and widening of the original single arched windows.

Local Detail & Diversity	<b>The Square SW range:</b> curved stone forestairs with ironwork railings giving access to upper flats (fig 3). <b>The Cottages:</b> pointed-arched entrances under gablets (fig 8). <b>The Steading:</b> half dormers projecting above the eaves with ashlar surrounds and piended slate roofs; entrance doors are defined by a large ashlar surround incorporating small window and central moulded pediment (fig 7).
Open Spaces, Trees & Landscaping	Open green space enclosing the village with agricultural land to east (fig 1); Riverside setting and mature trees. Drying green (The Square); former bowling green (fig 4). Small planting strips to the front of cottages (fig 5), and gardens to the rear (The Square); Small front gardens (Ochil View). Low stone boundary walls and hedging (fig 8).
Public Realm	Layout of the model village creates a general public realm. Traffic is excluded from the interior of the village which is occupied by lawns and gravel pathways.

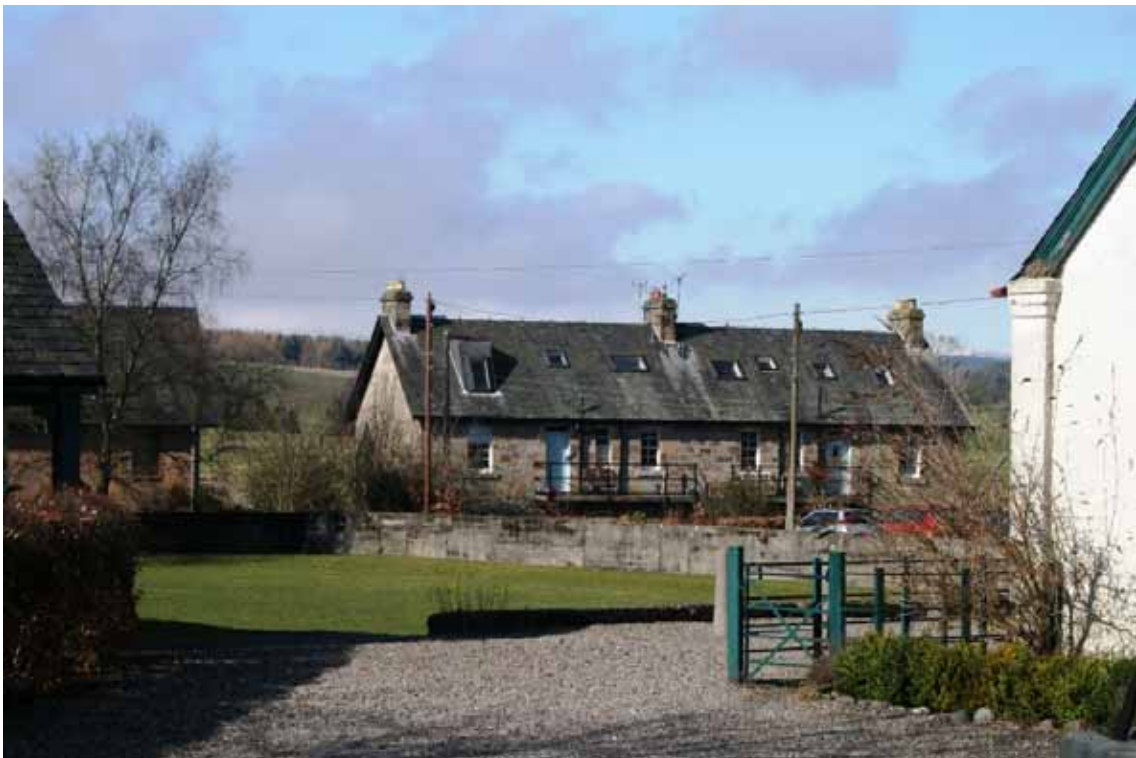
Fig 4: looking north-west across the former bowling green to the rear of Nos. 1-4 Allan View. This 2-storey block is reduced in scale due to the site levels dropping towards the river. The roofscape is prominent and important but has had inappropriate changes with rooflights in a variety of sizes and positions introduced, and a poorly designed dormer which interrupts the roofscape.

NEGATIVE FACTORS	
Building Design Scale, Plot	One new block of housing on Allan View has had minimal impact due to topography sloping reducing its scale when viewed from the central area; it has also retained the size and scale of the adjacent block. Some properties have rear large extensions which compete with the scale of the original cottages.
Building Elements	<b>Incremental change and loss of original fabric</b> <b>Windows:</b> The Square NE section: enlargement of original arched single windows to form double rectilinear windows with flat lintels; The Square SW section (fig 3): 2-storey row has almost entirely lost its original windows and has a mix of styles and materials to the detriment of the terrace. This has occurred in other areas. <b>Roofs:</b> introduction of dormers, roof lights and roof vents of varying styles and in varying locations breaking continuity of the roofscape (e.g. The Square, Allan View, fig 4); large continuous box dormers on The Clachan.

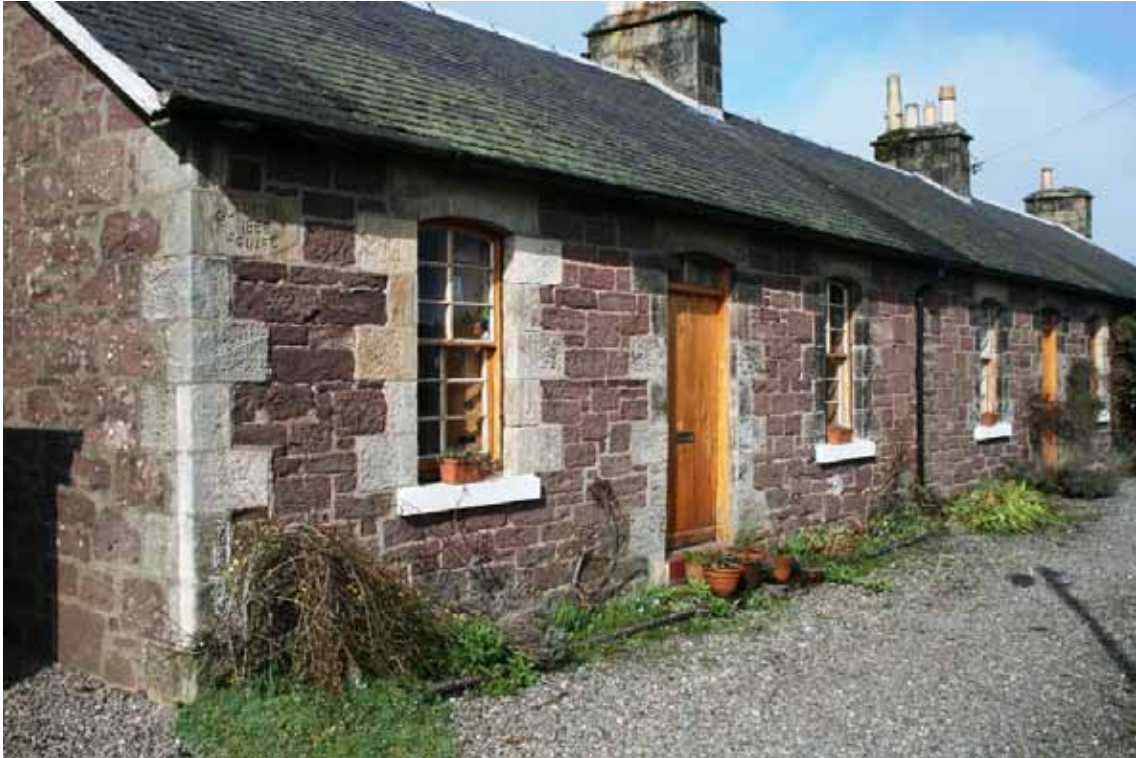
Fig 5: detail of one of the cottages of The Square with a carved stone 'Gladstone Square 1868'. This unaltered cottage illustrates all the characteristics of the original houses: contrasting red and cream sandstone, segmental window and door lintels, 6 over 6 laying pane timber sash and case windows (originally painted finish), boarded door with 2 pane lay-light and small planting strip in front of the cottage. The quality of materials and attention to detail illustrate Pullars intention to construct an attractive factory village.

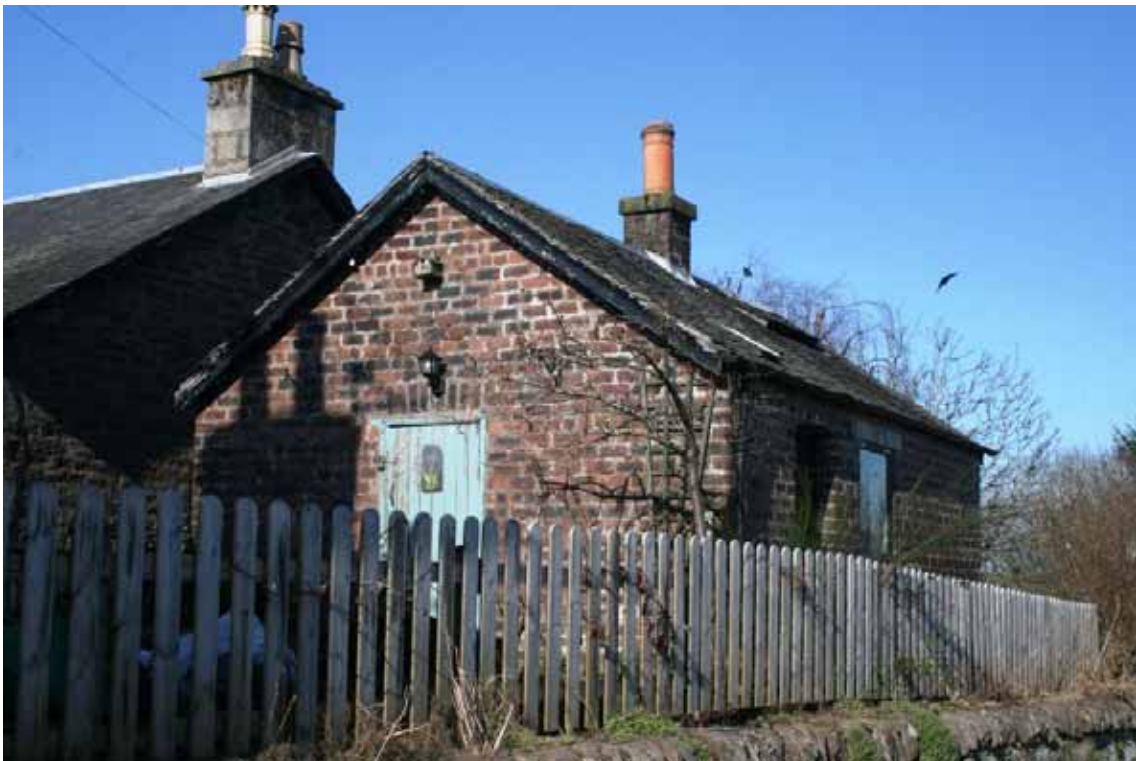
Fig 6: outbuildings, originally wash houses, privies or coal sheds, form an important contribution to the character of the conservation area and are an integral part of the planned model village. They are constructed in brick, but maintain the architectural detail of the cottages such as segmental arches over openings.

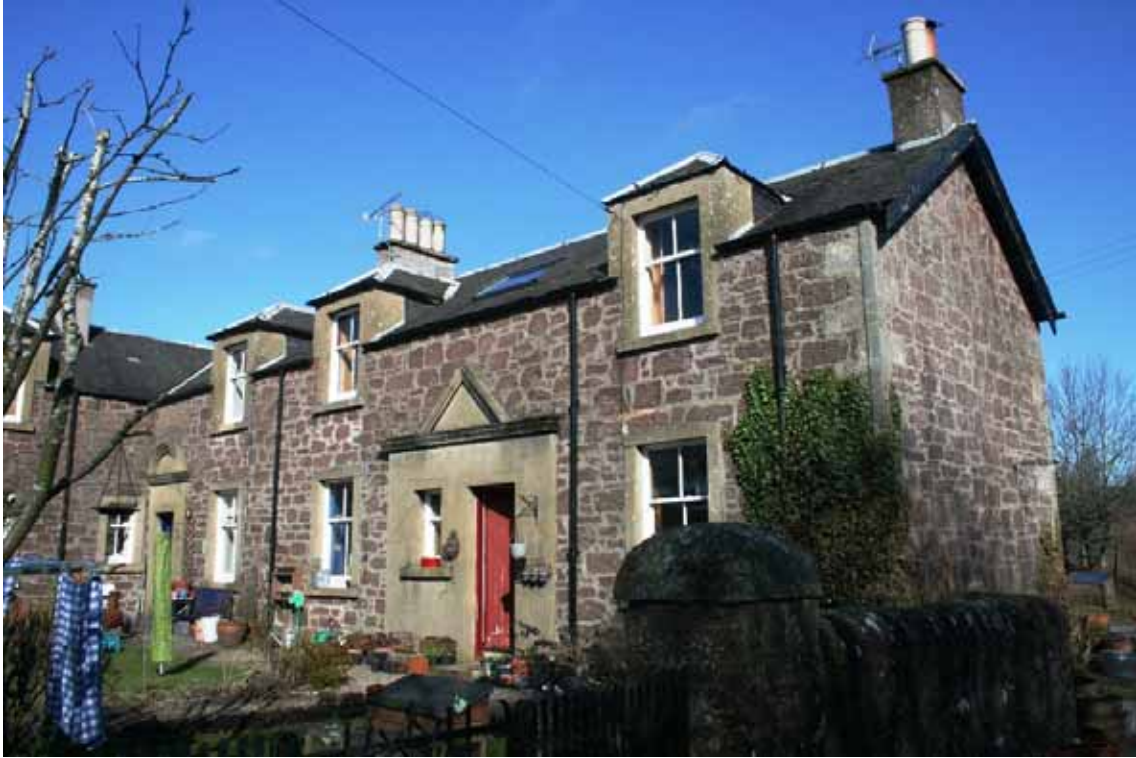
Fig 7: west elevation of The Steading; the houses in the southern section of the village were designed for different uses and this is reflected in their architectural style although there is a continuity in the use of materials such as the red sandstone. Note the eaves dormers and distinctive door surrounds with small pediments over.

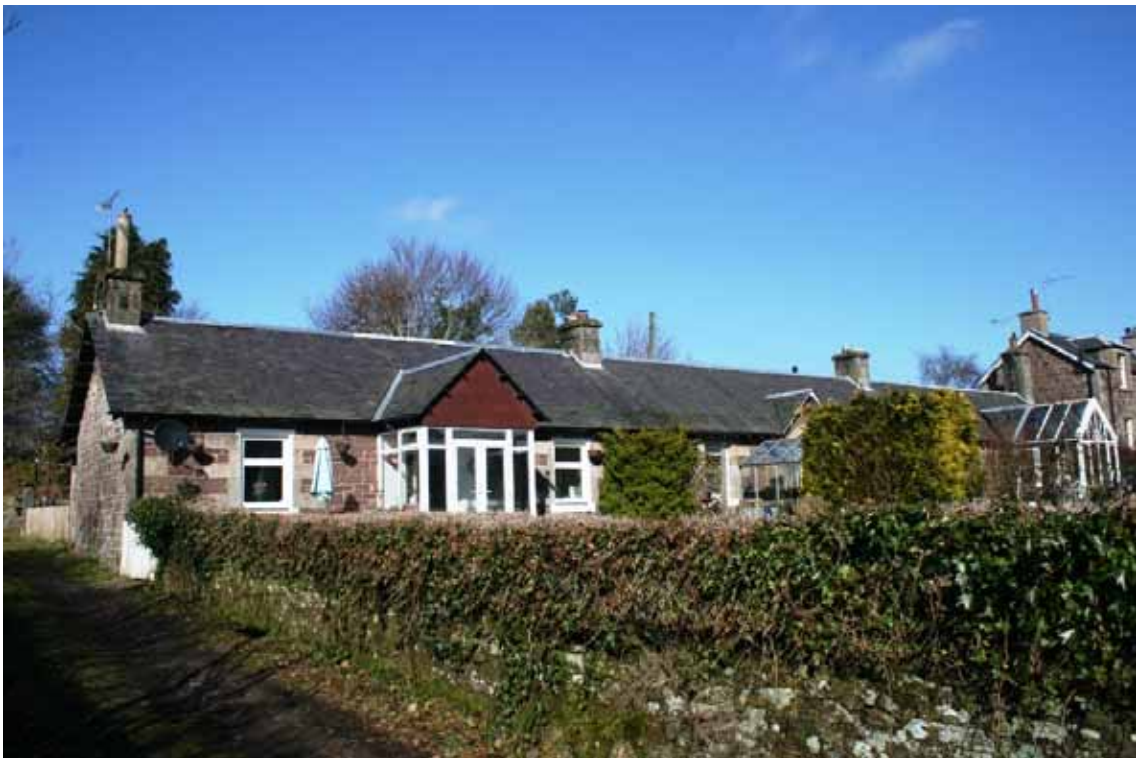
Fig 8: adjoining The Steading, The Cottages continue the more rural, less formal feel of the southern end of the village. A low row of 3 houses with long front gardens enclosed by hedging and stone boundary walls. Two of the original small gabled entrances have been extended with entrance porches which are not part of the original design.
